Phase I Test Results

Joint Test Protocol for Cadmium Alternatives for High Strength Steel

NAVAIR Pax River, Inorganic Coatings
301-342-6183, erin.beck@navy.mil

January 2006

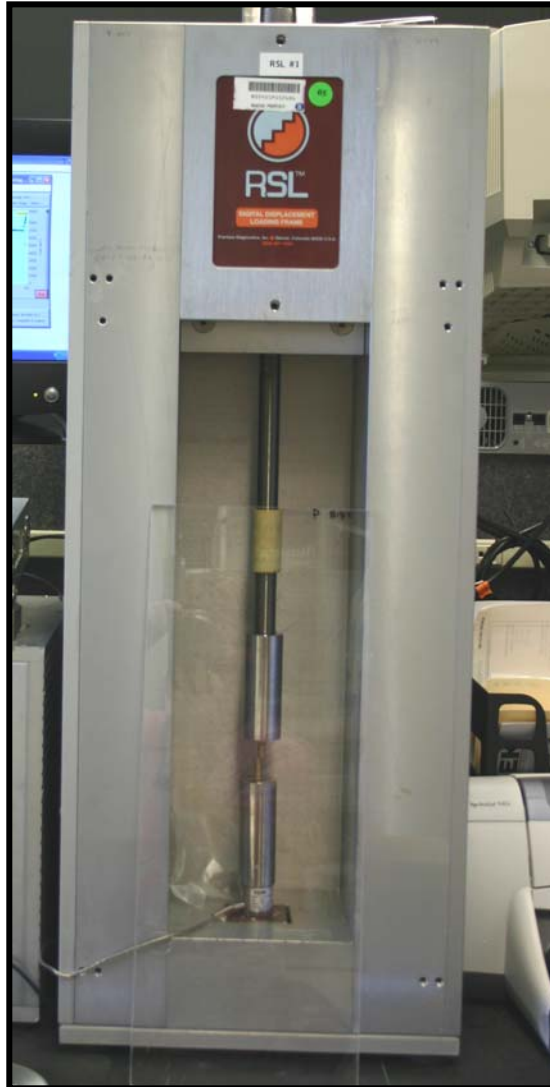
- **Acceptance Criteria:** 4 of 4 specimens sustain 75% notch fracture strength (NFS) load for 200 hours without fracture; **OR** 1 of 4 specimens fracture in less than 200 hours **and** the remaining 3 sustain at least 1-hour at 90% NFS during subsequent incremental step loading.
- **Specimens:** ASTM F 519 Type 1a.1, 4340 alloy steel, HRC 51-53.
- **All coatings passed this test except Sn-Zn.** Failure analysis showed specimens had large intergranular fracture areas initiated at the notch surface, indicating embrittlement of the steel during processing.

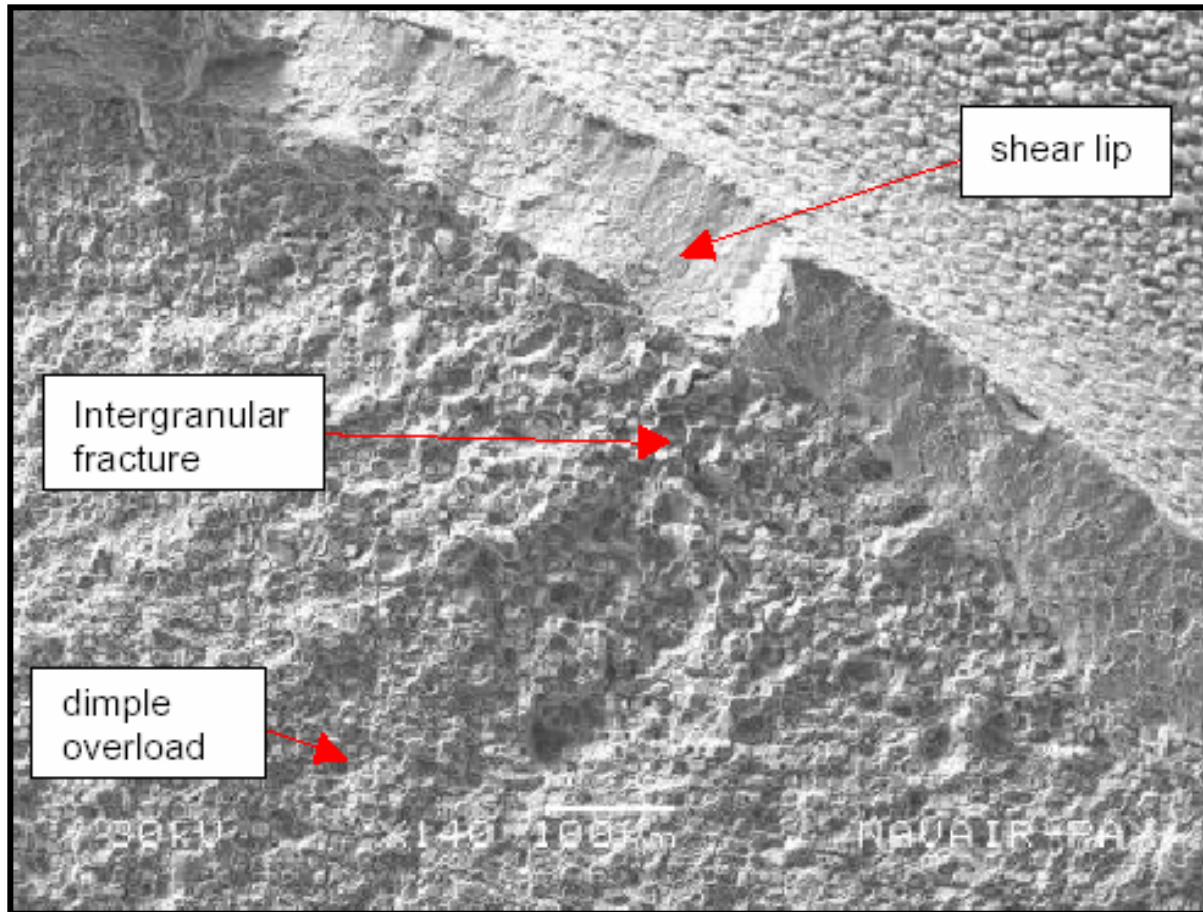
Brush Zn-Ni specimen #4, failed at 75.2% NFS @ 16.9 hrs.

<u>Brush ZnNi</u>	<u>Fracture Strength (%)</u>	<u>Time to Failure (hrs)</u>
1	89.2	202
2	90.4	202
3	90.6	203
4	75.2	16.9

Failure Analysis:

- **Bar #1:** Fully ductile.
- **Bar #4:** Intergranular fracture (embrittlement) initiated below the surface.

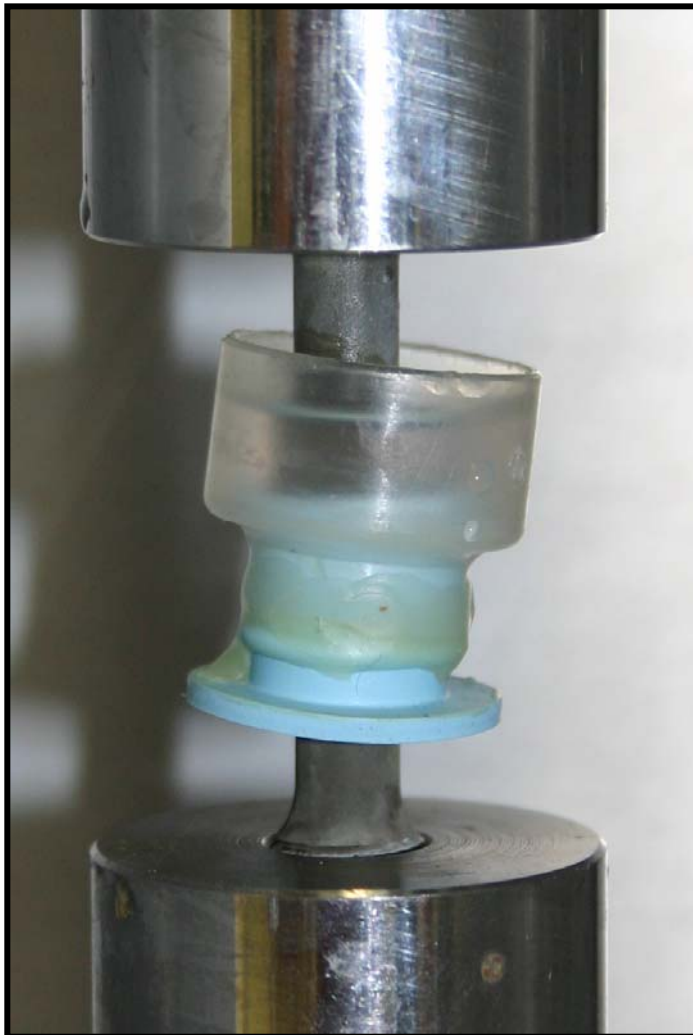
Test Setup

- All specimens loaded separately (no gang loading).
- Service fluids in cup isolated around notch, approximately 2-3 ml fluid in each cup.
- Fluids were not replenished during test – parafilm wrapped around grips prevent evaporation.

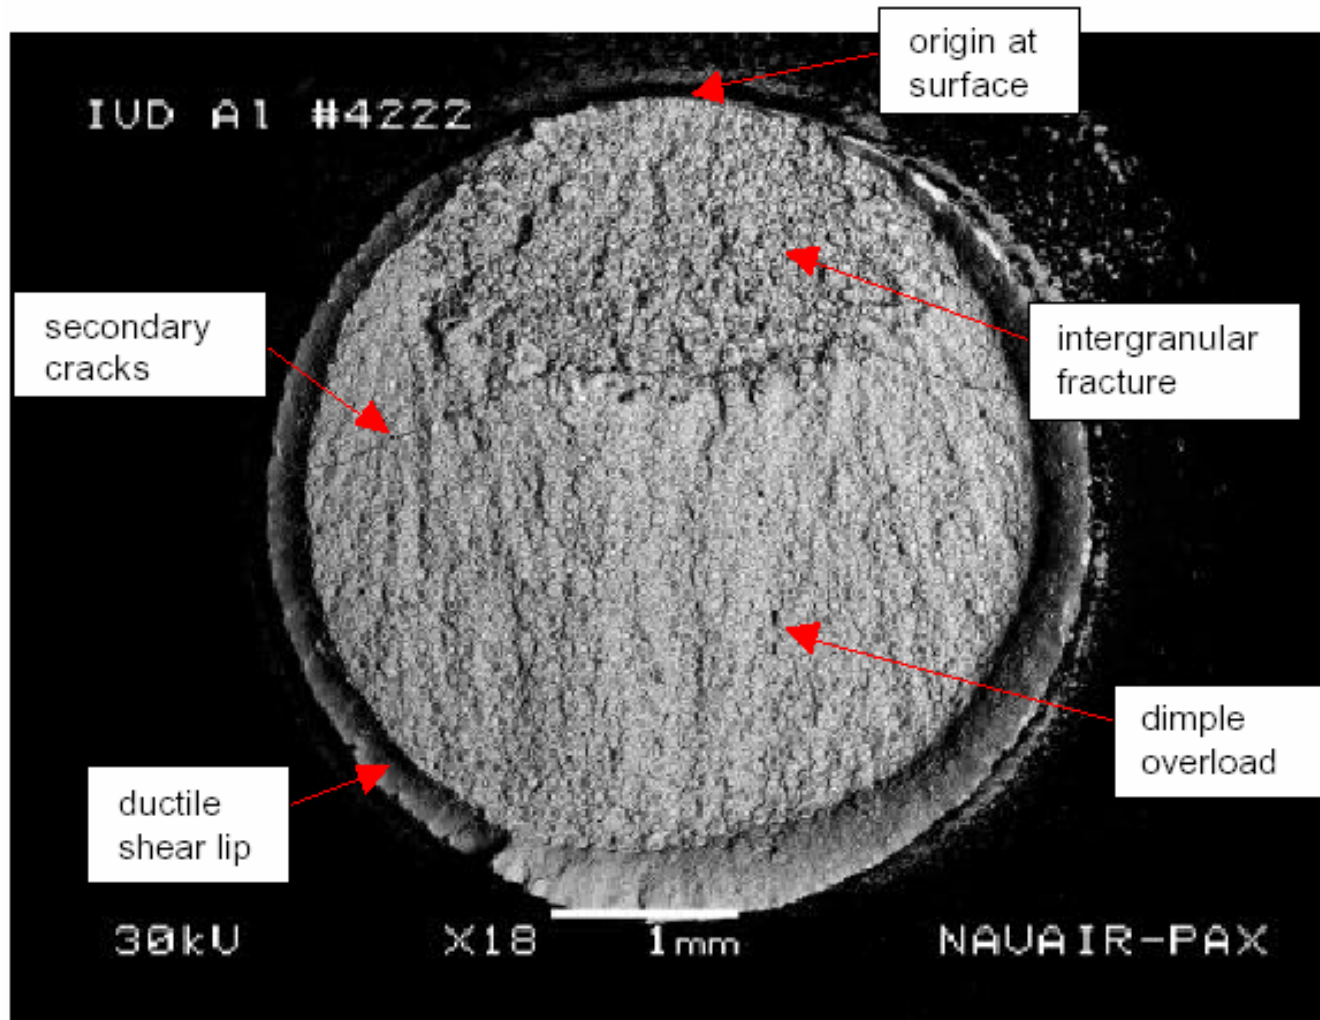
IVD A1 tested in DI water, failed at 45% NFS @ 18 hrs.

<u>Coating</u>	<u>Fracture Strength (%)</u>	<u>Load at Failure (lbs)</u>	<u>Time to Failure (hrs)</u>	<u>Pass/Fail</u>
LHE Cadmium	73.9	6958	28.8	N/A
IVD Aluminum	50.2	4720	18.2	N/A
Alumiplate	95.0	8940	33.3	PASS
Sputtered Al	47.7	4489	14.1	FAIL
LHE ZnNi (Dipsol IZ-C17)	70.2	6402	28.1	CLOSE
ZnNi (Boeing acidic)	46.4	4370	6.6	FAIL

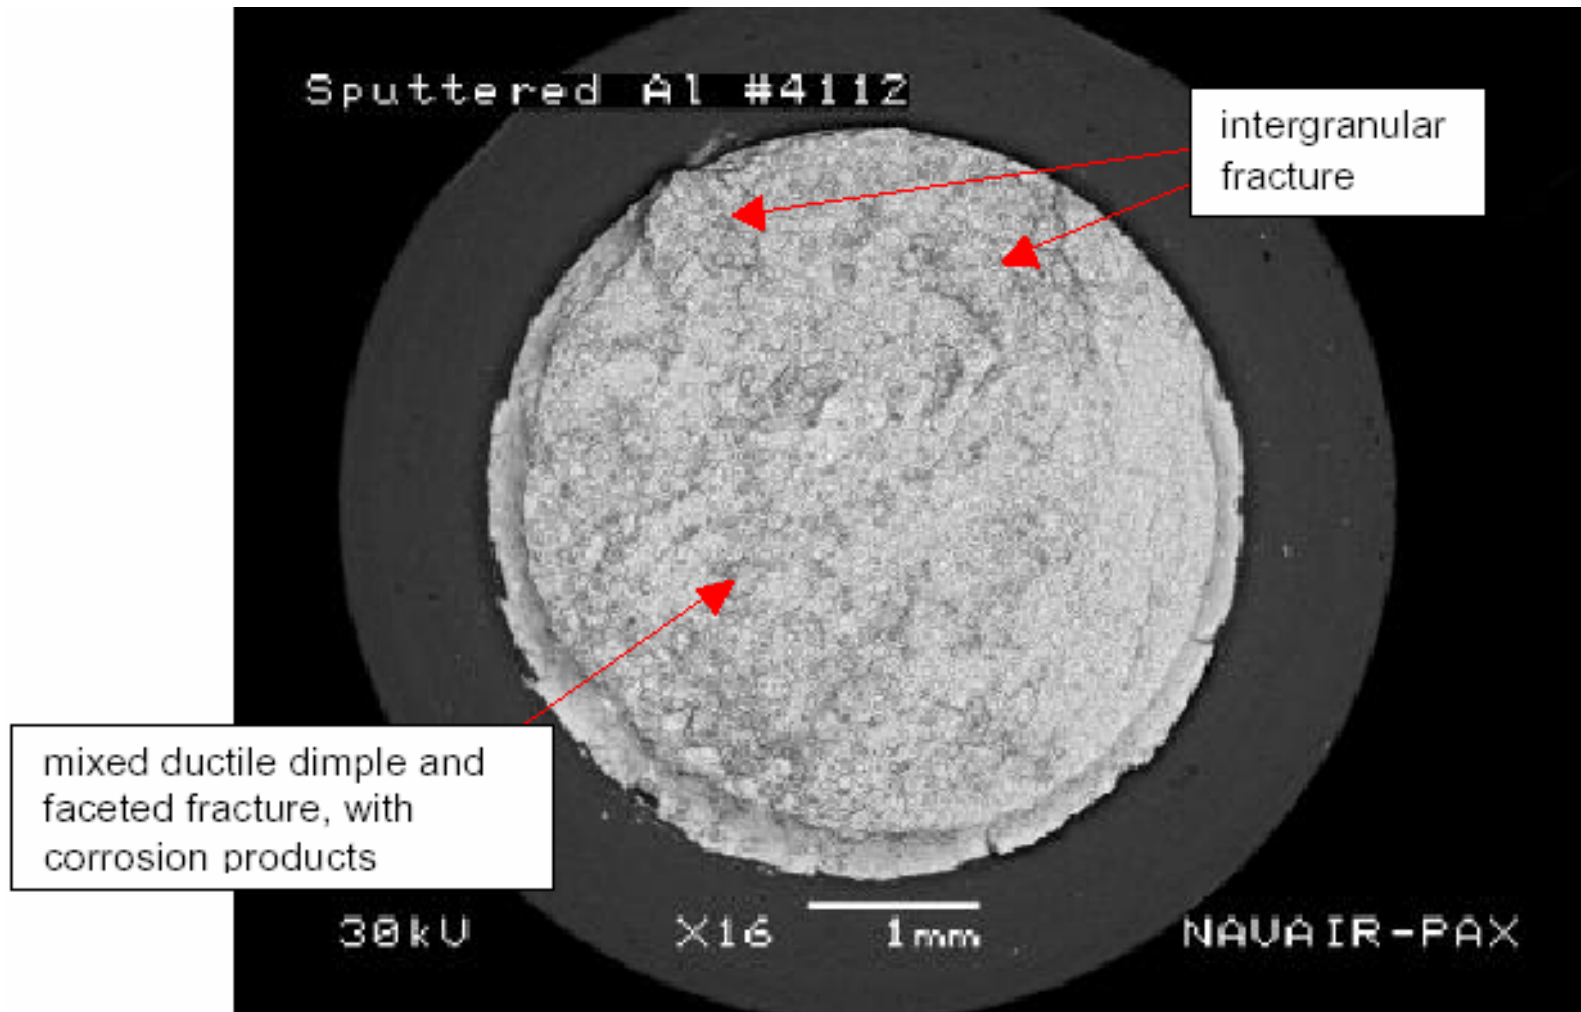
Sputtered Aluminum tested in seawater, failed at 55.5% NFS @ 25.7 hrs.

<u>Coating</u>	<u>Fracture Strength (%)</u>	<u>Load at Failure (lbs)</u>	<u>Time to Failure (hrs)</u>	<u>Pass/Fail</u>
LHE Cadmium	77.7	7316	29.7	N/A
IVD Aluminum	52.7	4956	24.6	N/A
Alumiplate	93.9	8841	40.3	PASS
Sputtered Al	49.0	4610	12.5	FAIL
LHE ZnNi (Dipsol IZ-C17)	57.6	5253	20.2	CLOSE
ZnNi (Boeing acidic)	46.4	4364	7.1	FAIL

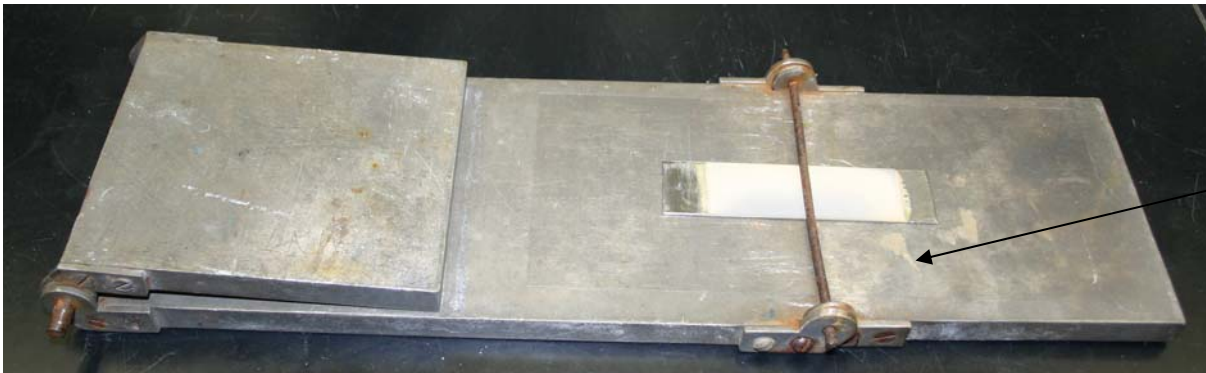
- **Acceptance Criteria:** No separation (flaking, peeling, or blistering) of the coating from the basis metal. Cracking is acceptable.
- **Test Setup:** Bend specimen back and forth through 180° until coating and/or substrate ruptures.
- **Performance:** IVD Aluminum, Brush LHE Cadmium and Sermetel 249/273 had adhesion problems.

Protective
transparency
sheet under
panel.

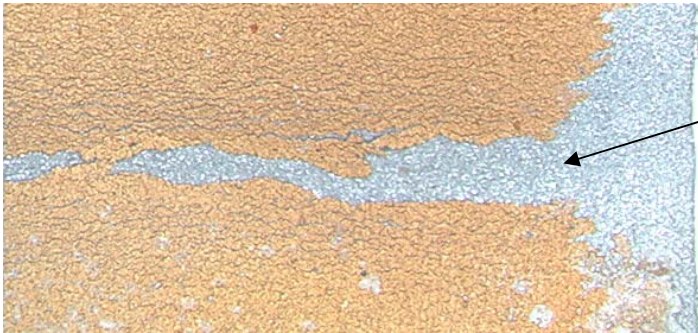
IVD Aluminum coating
flaked off of panel.

SEM/EDS analysis
confirm exposed
substrate.

Coating	Pass/Fail	Comment
LHE Cadmium	Pass	
IVD Aluminum	Fail	Significant flaking/peeling
Alumiplate	Pass	Very minor peeling at broken edge
Zn-Ni (Boeing, acidic)	Pass	
Sputtered Aluminum	Pass	
Brush LHE Cadmium	Fail	Significant flaking/peeling
Brush Sn-Zn	Pass	
Sermetel 249/273	Fail	Significant flaking/peeling/blistering
Brush Zn-Ni	Pass	
Zn-Ni (Dipsol LHE)	Pass	
Sn-Zn	Pass

Additional evaluation of IVD Aluminum and Alumiplate bend adhesion specimens was conducted to determine if the aluminum coatings had lifted from the substrate steel panel or whether the chromate conversion coating had lifted from the aluminum coating, and the aluminum coating remained adherent to the steel panel. Evaluation indicated the aluminum coatings had lifted from the steel panel in both cases. The Alumiplate coating had only slightly lifted from the panels during the bend adhesion test, and a thin razor was subsequently used to gently peel an already lifted portion of the coating up from the panel to facilitate further evaluation. See attached pdf document titled Cadmium Alternatives Substrate for detailed analysis of the specimens.

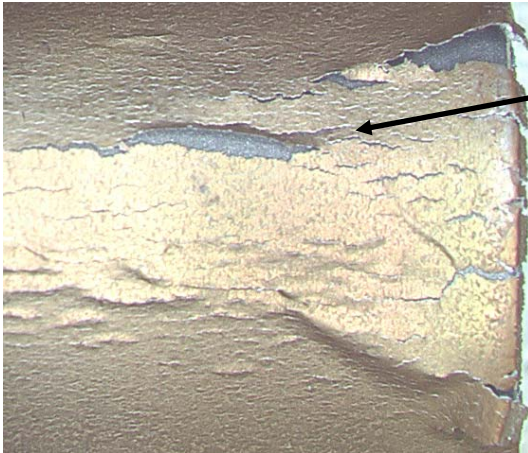
Brush Cd
coating flaked
off of panel.

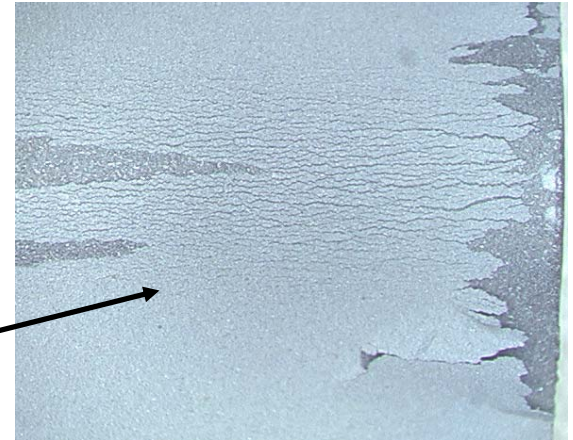
Sermetel 249
coating flaked
off of panel.

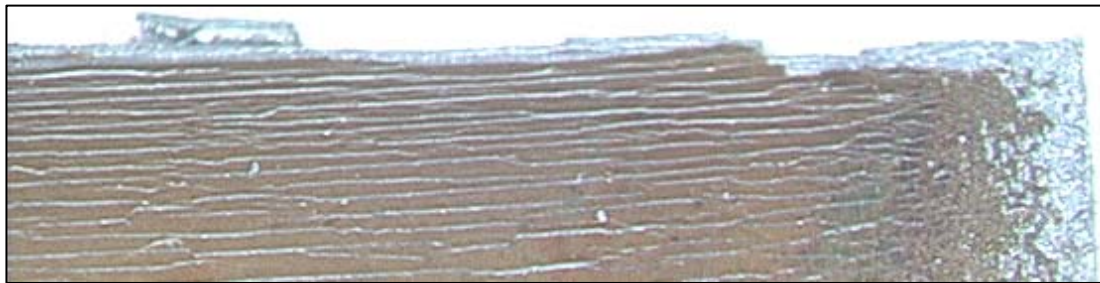
Brush ZnNi coating cracked but did not pop off panel.
